Combroke Parish Council

Consultation for Application 19/00361/FUL

At: The Little House, Combrook, CV35 9HP

Proposed: Enlargement of parking area, erection of retaining wall

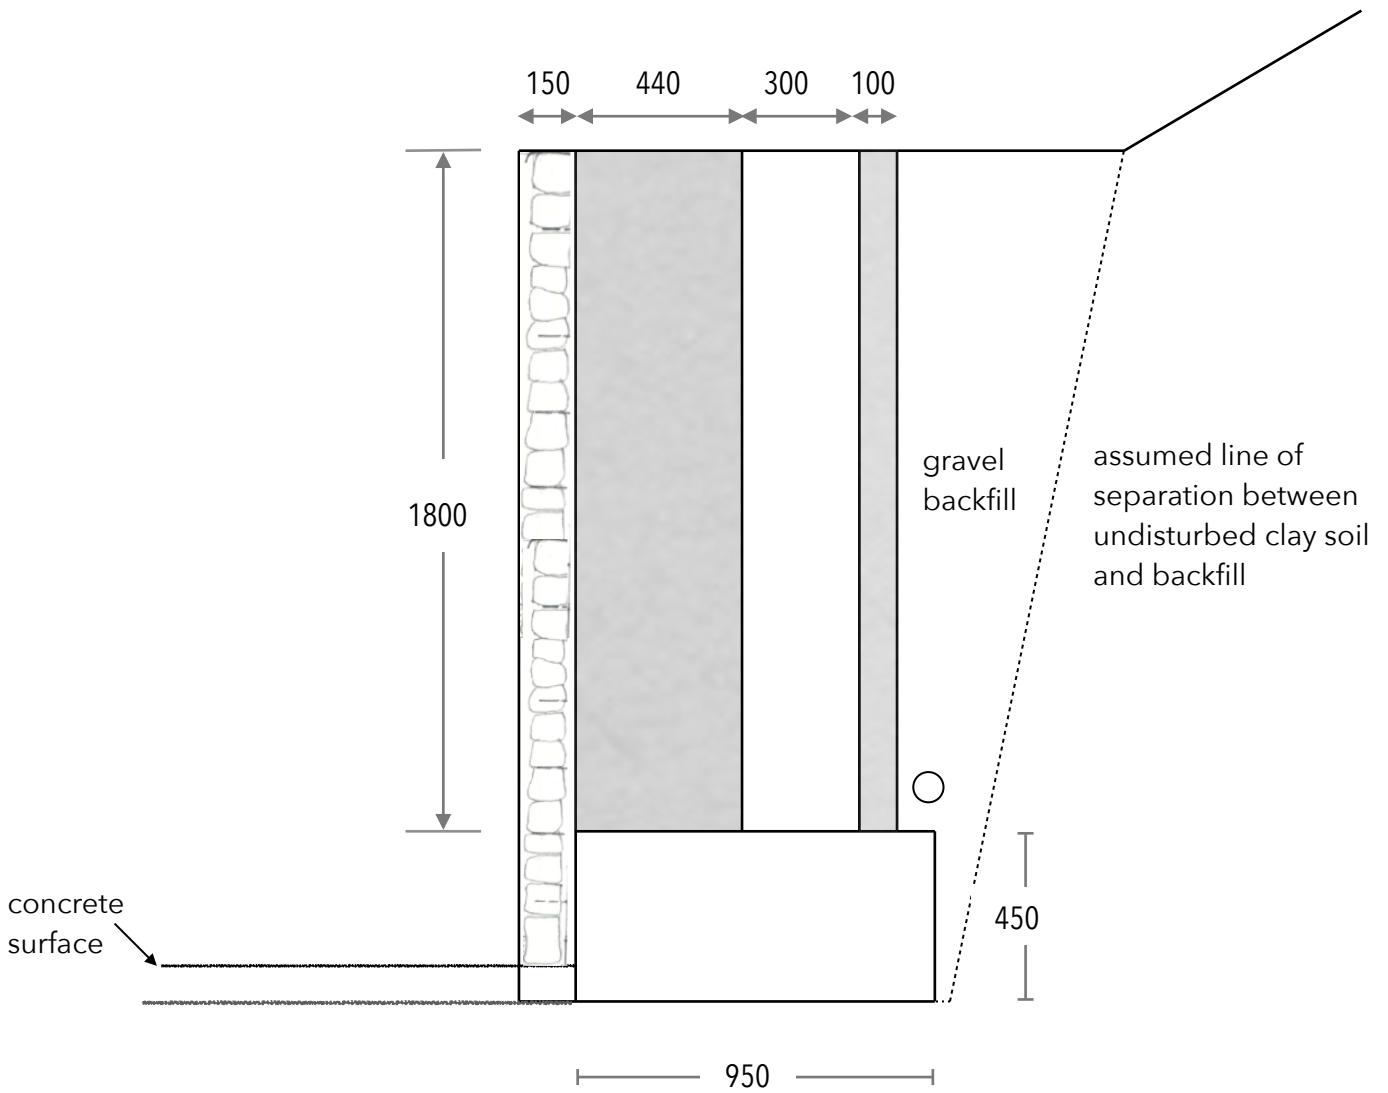
Dimensions (mm), as given by applicant

- 3.2. Both the amended drawing 412 42 RevA and the sketch included with the structural engineer’s calculations continue to show the top of the base of the retaining wall to be level with the top surface of the parking area implying that the base of the wall is a foundation below ground level.

- 3.3. This is NOT the case as has been shown previously in photographs and is still evident where stone cladding has not been fixed to the wall. The surface of the parking area is some 300 -350 mm below the height shown and the base of the wall is built directly on the top of the excavated surface which is now known to be clay as discovered by the builders in November 2018 and revealed in the Agent’s letter.

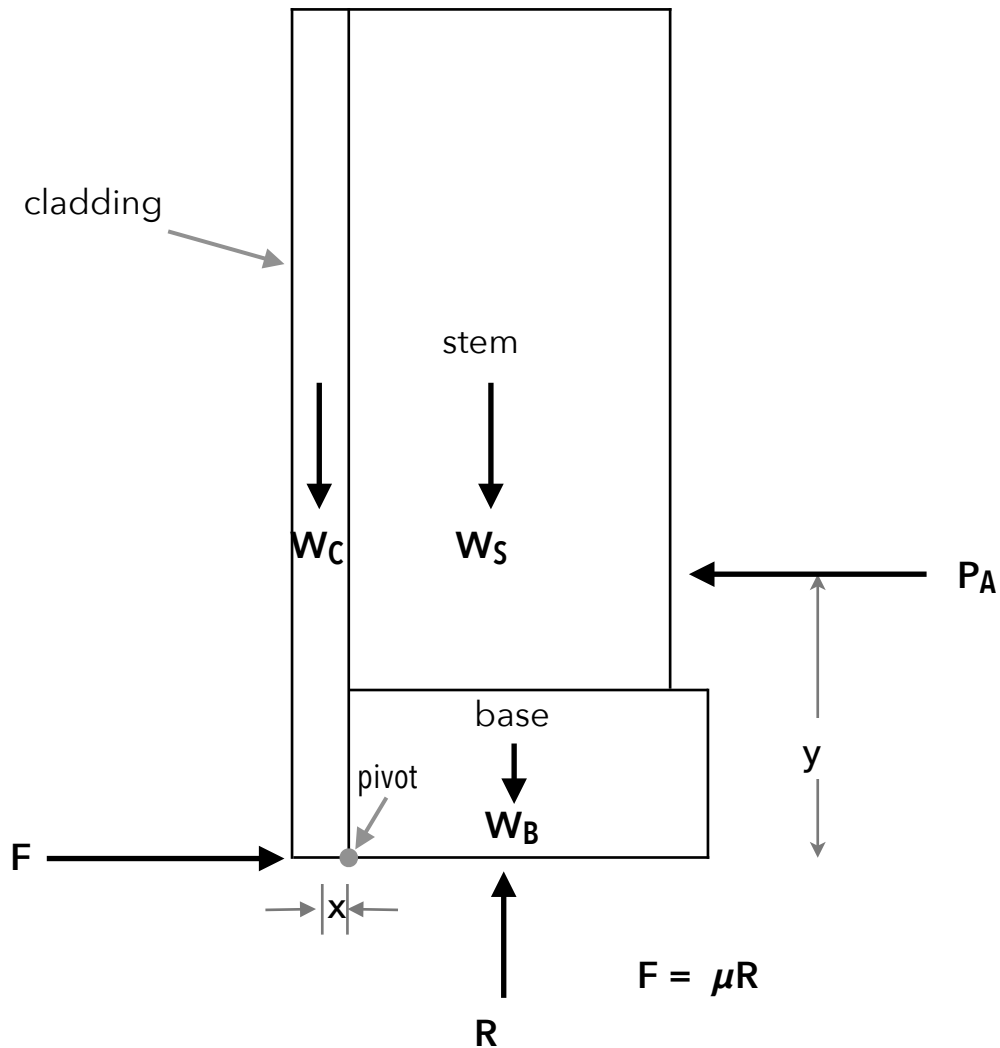
Retaining Wall - Forces

- ➡ The weight of the 150mm thick natural stone cladding added to the front face of the wall is not taken into account in any calculations. The fact that there is no toe to the base of the wall means that the cladding contributes an overturning moment that must be added to lateral forces arising from the active pressure from the retained soil . If all other figures proposed by the structural engineer are used, the additional consideration of the cladding alone results in a revised factor of safety of 1.89 which is a FAIL if the generally accepted minimum value of 2 is used.(See Appendix 1)

- ➡ The calculation presented to test resistance to sliding identifies an incorrect value for friction, and then fails to use it. The equation as presented simply compares a horizontal force with a vertical force. The value of friction presented is the internal friction angle of the soil. The soil has been found to be clay so the “worst case scenario” is actually the true scenario and the value that must be used is the coefficient of sliding friction between the underside of the cast concrete base and the clay soil. A typical value for this pair of materials is 0.3 (Ref. StructX.com). Again using all other figures proposed by the structural engineer, but accounting for the additional weight of the stone cladding which helpfully provides an *increase* in the friction force opposing sliding, the factor of safety is only 1.22 which is a FAIL using the accepted criterion. (See Appendix 1)

$$= 1.22 < 2 \quad \text{therefore is a **FAIL**}$$

$$\begin{aligned}\text{Factor of safety} &= \frac{\text{overturning moment}}{\text{restoring moment}} \\ &= \frac{20.14}{10.66} \\ &= 1.89 < 2 \text{ therefore is a } \mathbf{FAIL}\end{aligned}$$

In view of these issues the Parish Council is not convinced that the retaining wall as proposed and constructed has been demonstrated to be safe and requests that further analysis is undertaken and the appropriate remediation is proposed.

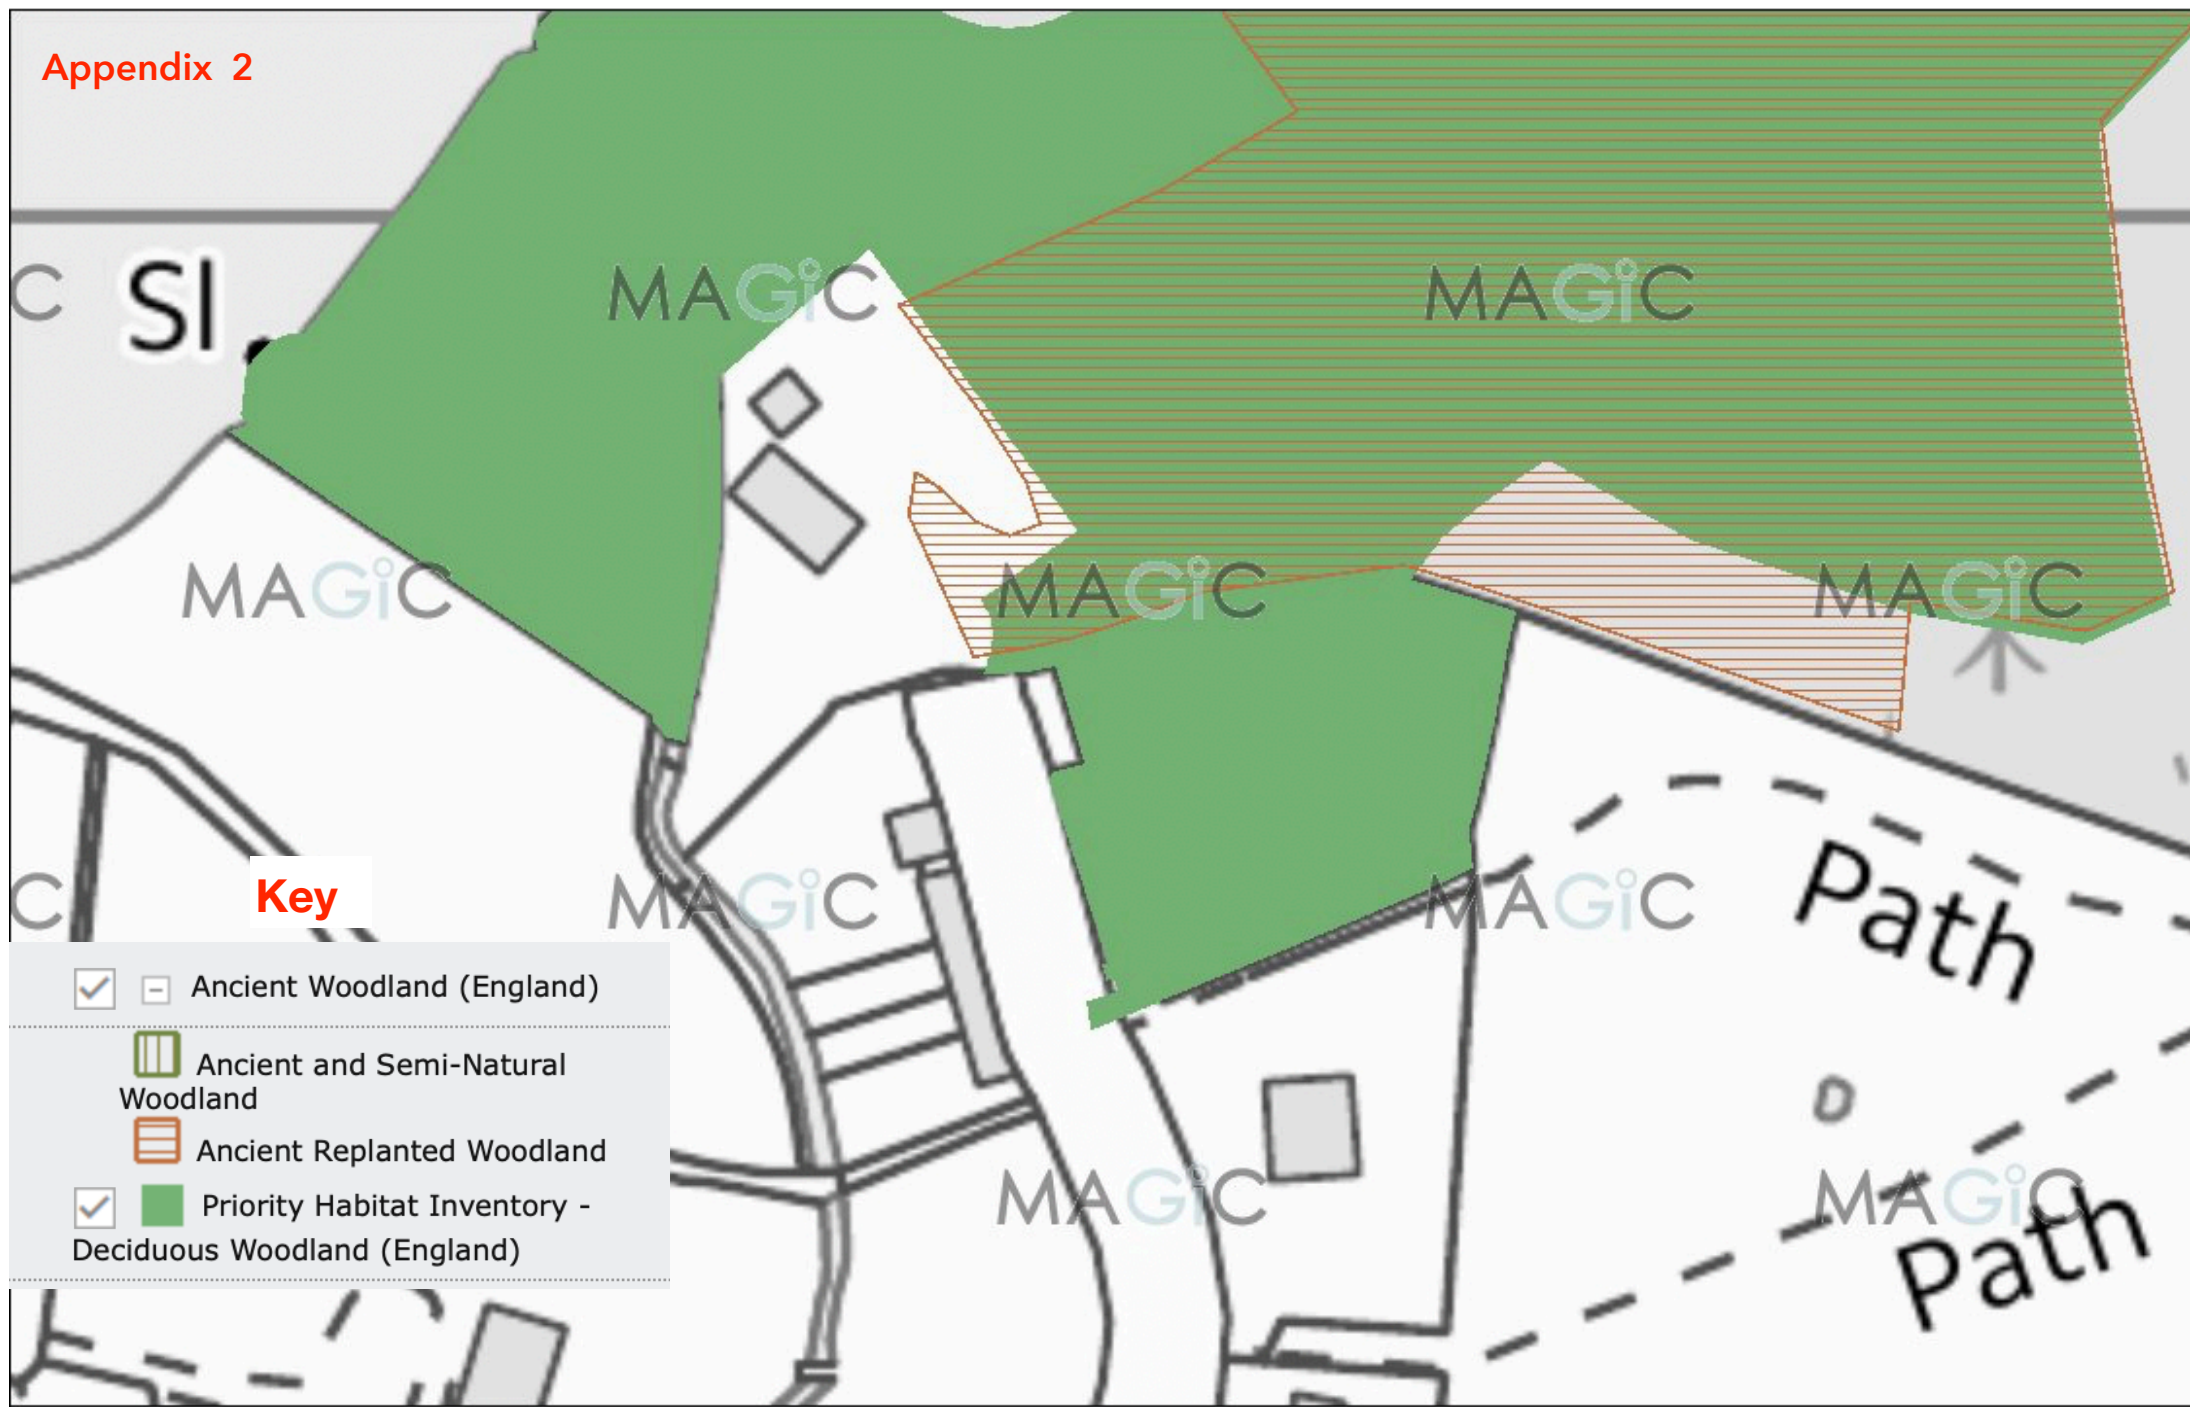
Appendix 2

- 5.2. The letter received from the Woodland Trust as a consultee identifies the area adjacent to the site to the north to be ancient woodland. The map (copy attached Appendix 2) taken from www.magic.defra.gov.uk shows that the retaining wall lies within 3 - 4 metres of the ancient woodland and that one of the trees harmed by the excavations was part of the ancient woodland.
